NACA RM E51D16

INVESTIGATION OF MECHANISMS OF BLADE FAILURE OF

FORGED HASTELLOY B AND CAST STELLITE 21

TURBINE BLADES IN TURBOJET ENGINE

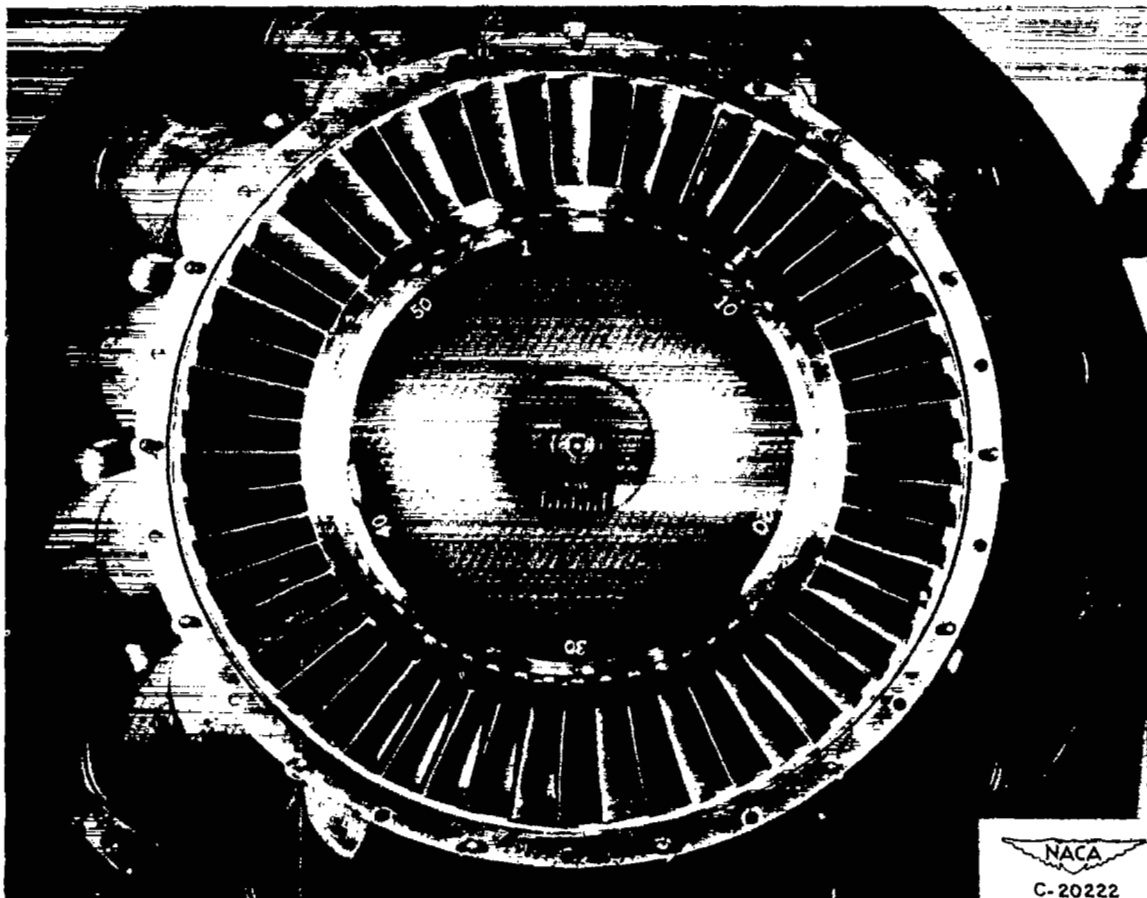
Figure 1. - Turbine rotor of Timken alloy before operation, alternately bladed with Hastelloy B and Stellite 21 turbine blades.

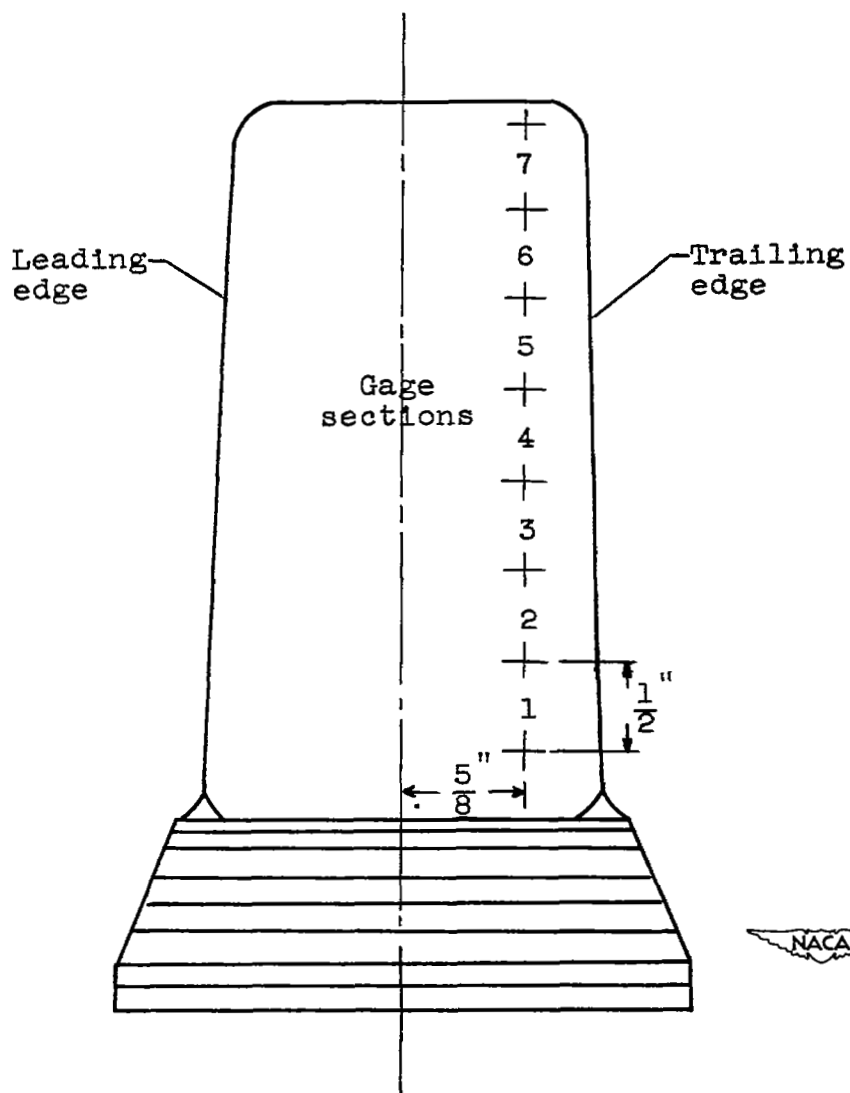
Measurement of blade and wheel elongation	Optical extensometer readings of an accuracy of ± 0.0001 in. between gage marks on two blades of each alloy and on the turbine wheel (see fig. 2)
Location and detection of blade cracks	Visual examination during engine shutdown and overhaul

Figure 2. - Location of scribe marks on convex side of turbine blade for measurement of elongation.

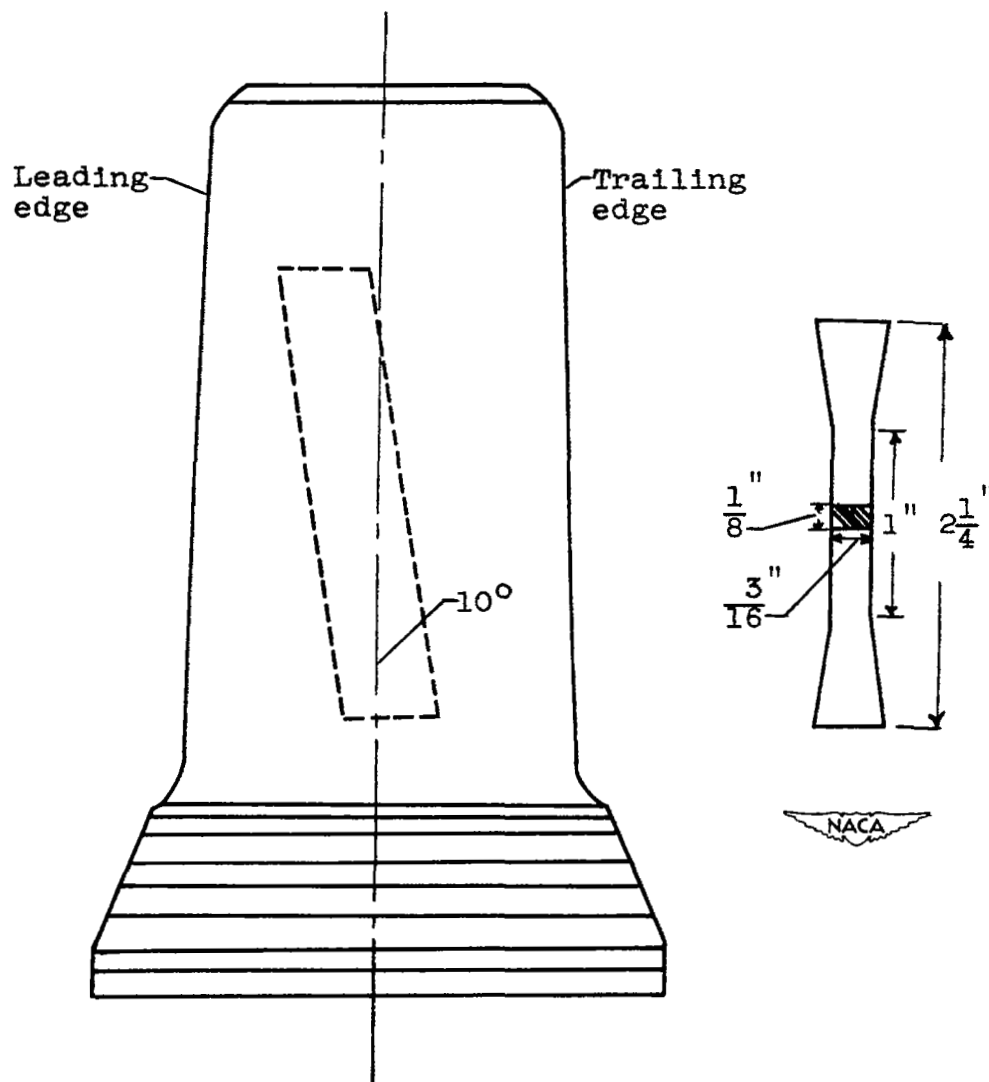
Loading system	Simple beam acting through system of knife edges
Furnace	Resistance type
Temperature control	Less than 5° F variation along specimen; average temperature variation $\pm 2^{\circ}$ F
Specimens	Cut from center of blade airfoil section (see fig. 3)
Test conditions	Stress and temperature same as estimated at midpoint of blade during engine operation

Figure 3. - Blade stress-rupture specimen and zone from which specimen is machined.

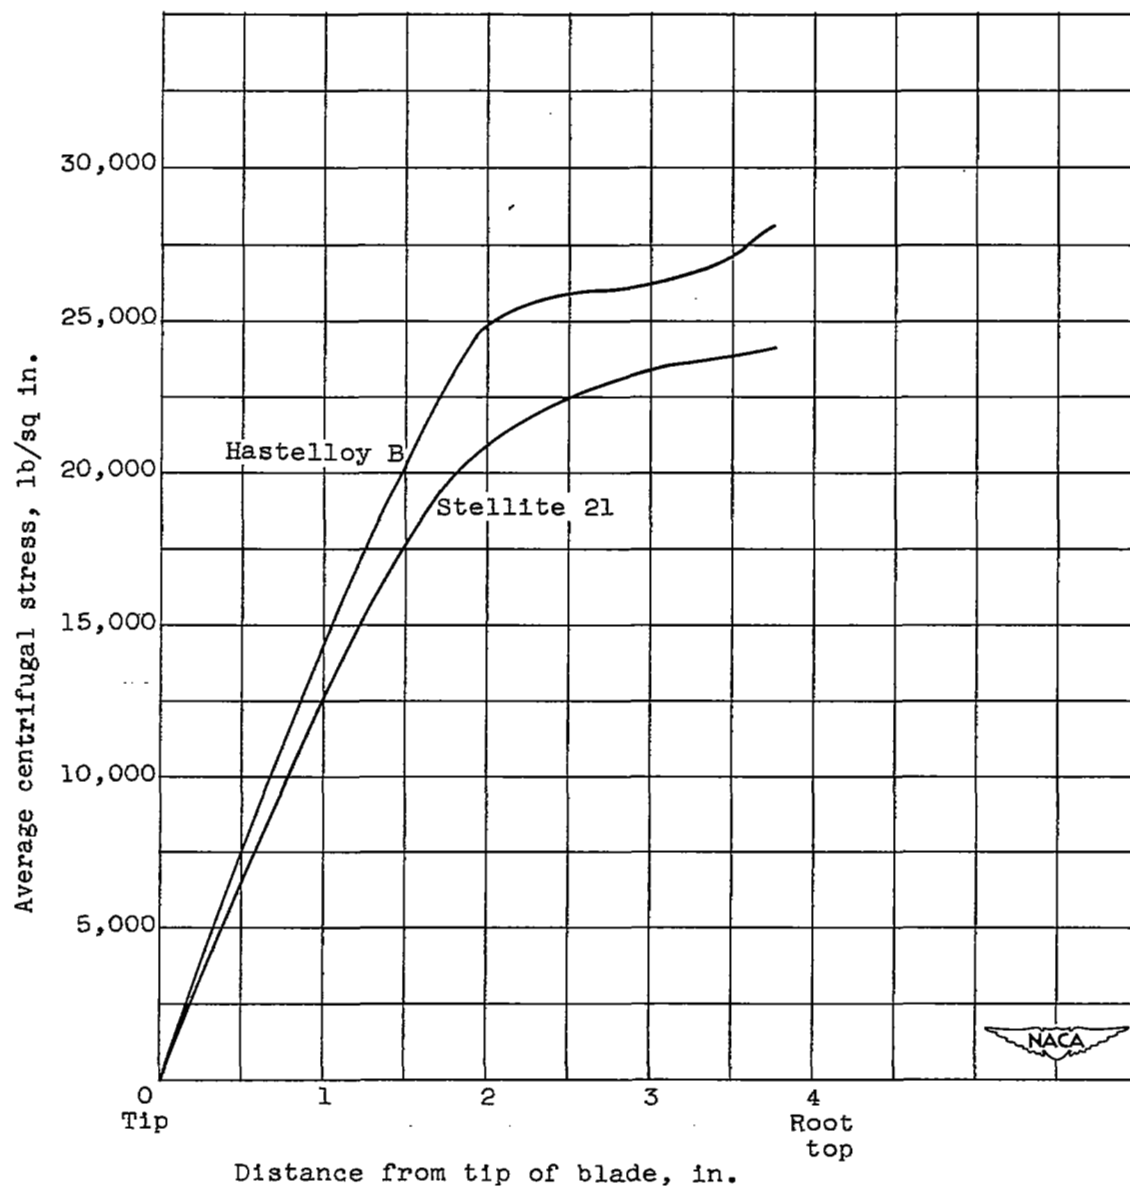
The results of the stress determinations based on the measured cross-sectional areas and 11,500 rpm for the two alloys Hastelloy B and Stellite 21 are plotted in figure 4. The stress curves are based on the average areas of six blades and an engine speed of 11,500 rpm.

Figure 4. - Average centrifugal stress distributions in Hastelloy B and Stellite 21 turbine blades at rotor speed of 11,500 rpm.

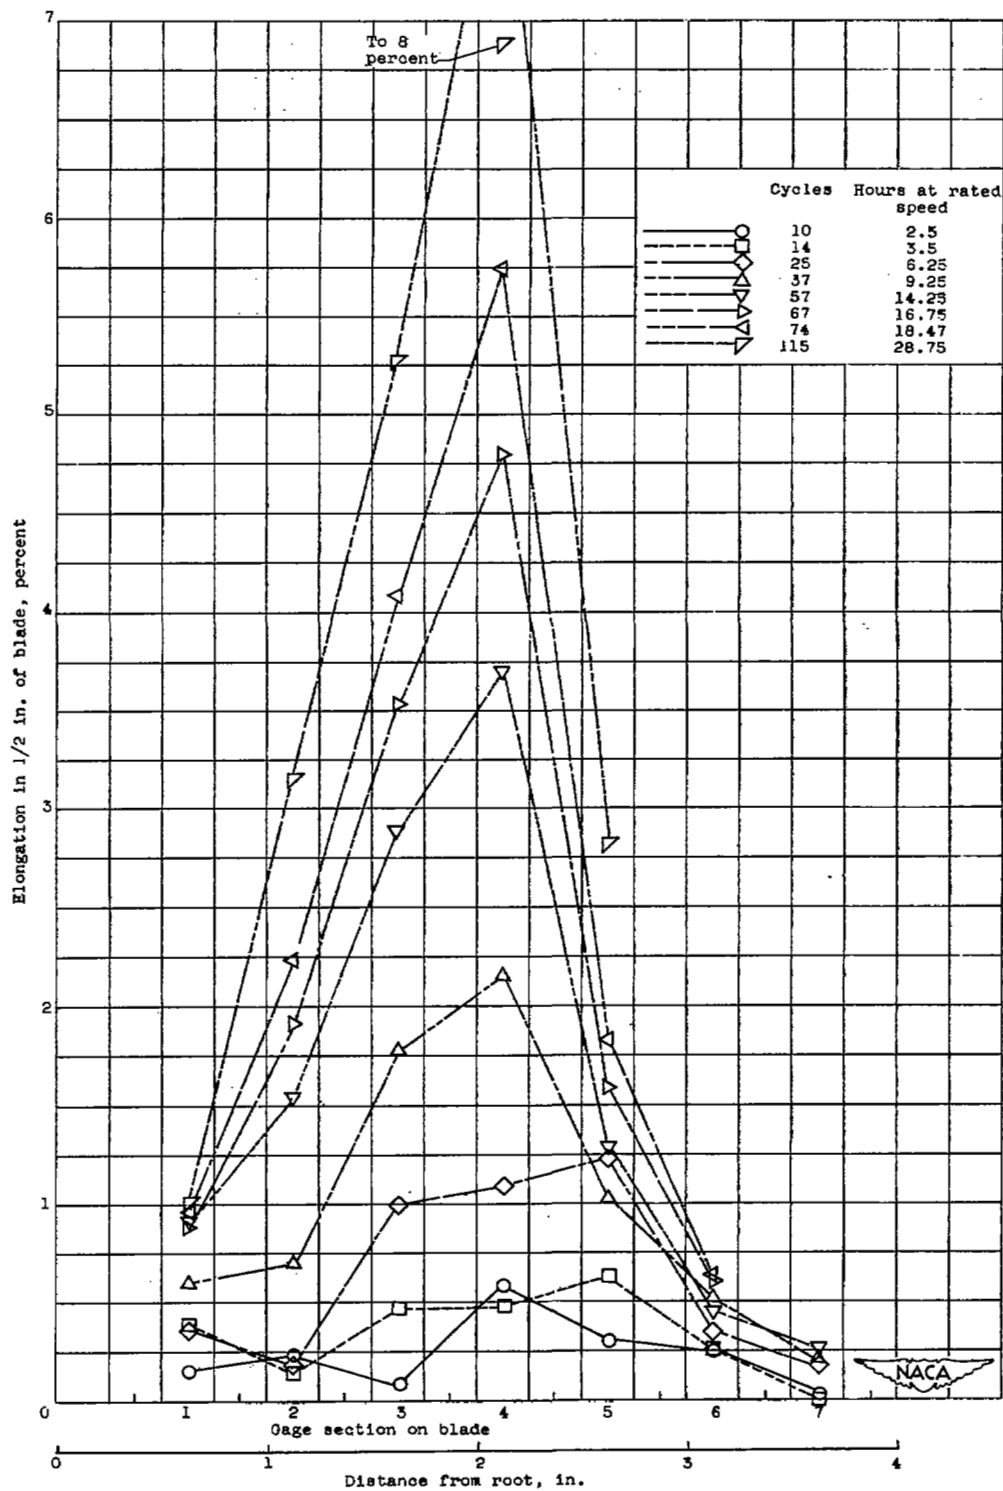
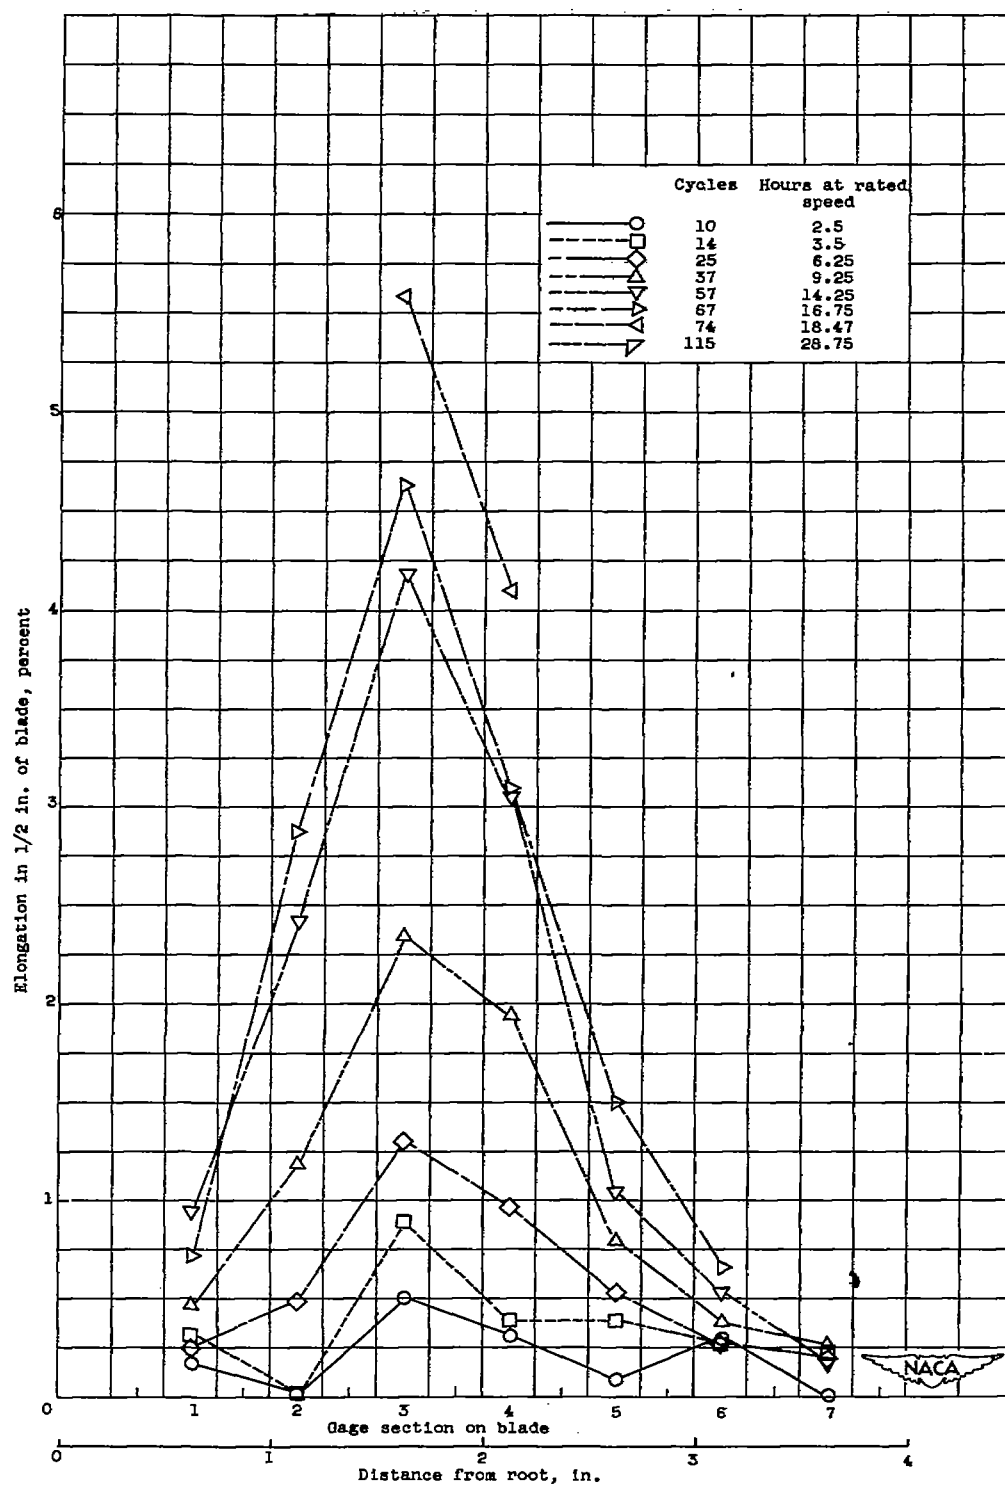
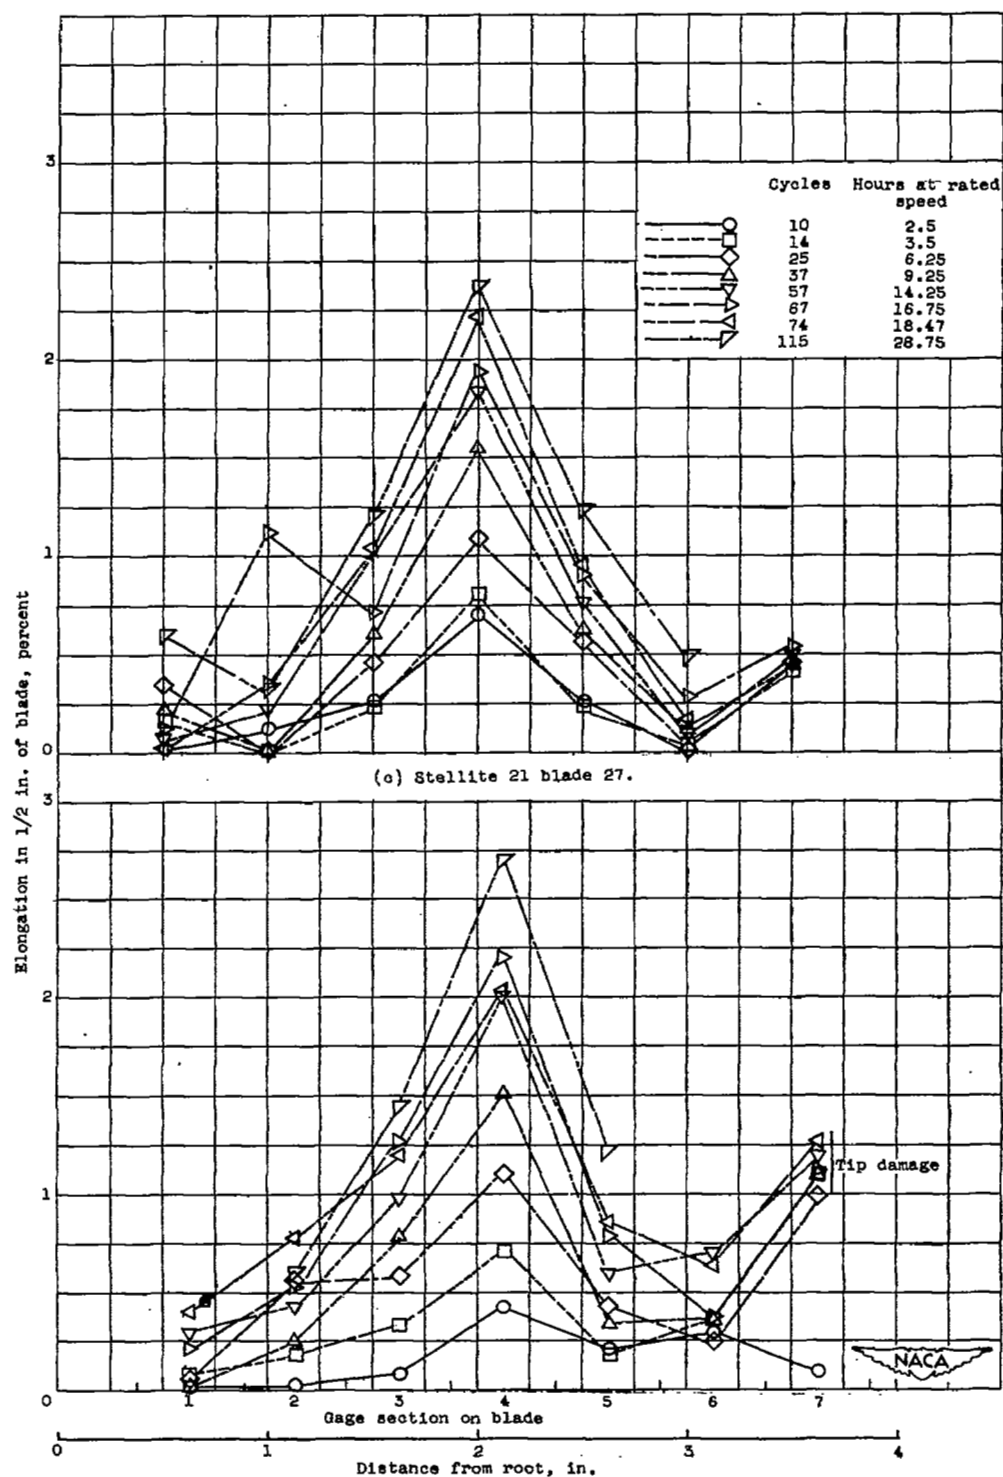
The results of the elongation measurements on the blades are presented in figure 15. Figure 16 shows the time-elongation curves for the entire blades and for the gage sections with a total elongation at the conclusion of test of greater than 1 percent. There was no measureable elongation in the 16-25-6 alloy turbine rotor.

(a) Hastelloy B blade 40.
Figure 15. - Elongation distributions along turbine blades.

(b) Hastelloy B blade 54.
Figure 15. - Continued. Elongation distributions along turbine blades.

Figure 15. - Concluded. Elongation distributions along turbine blades.

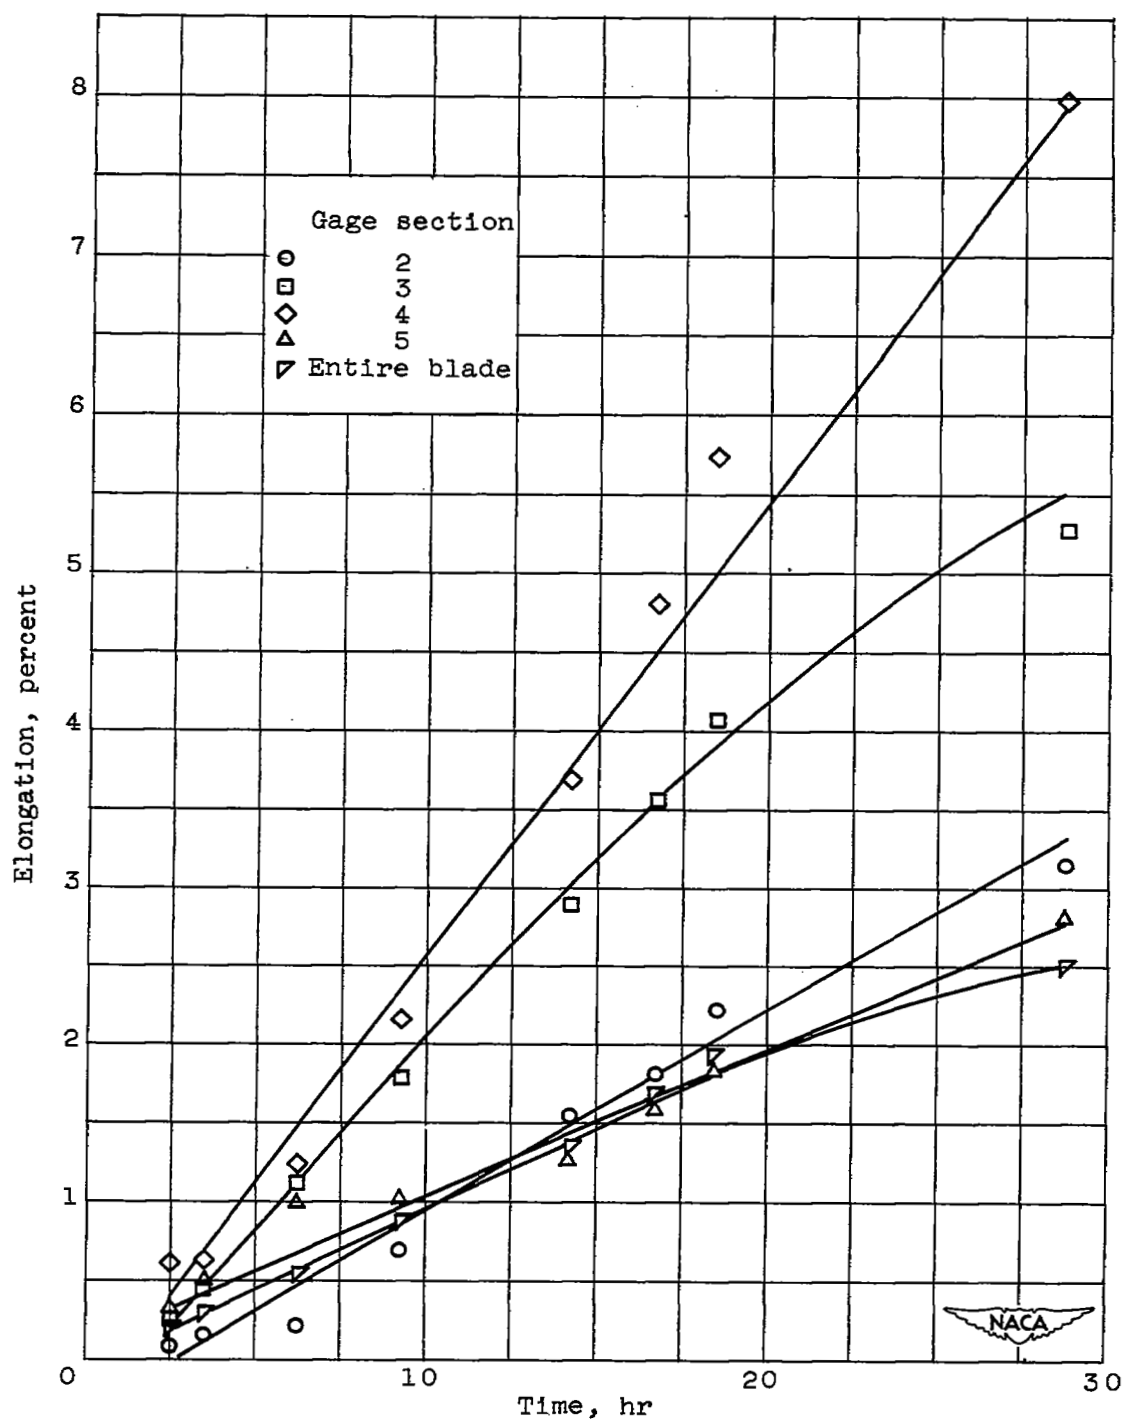
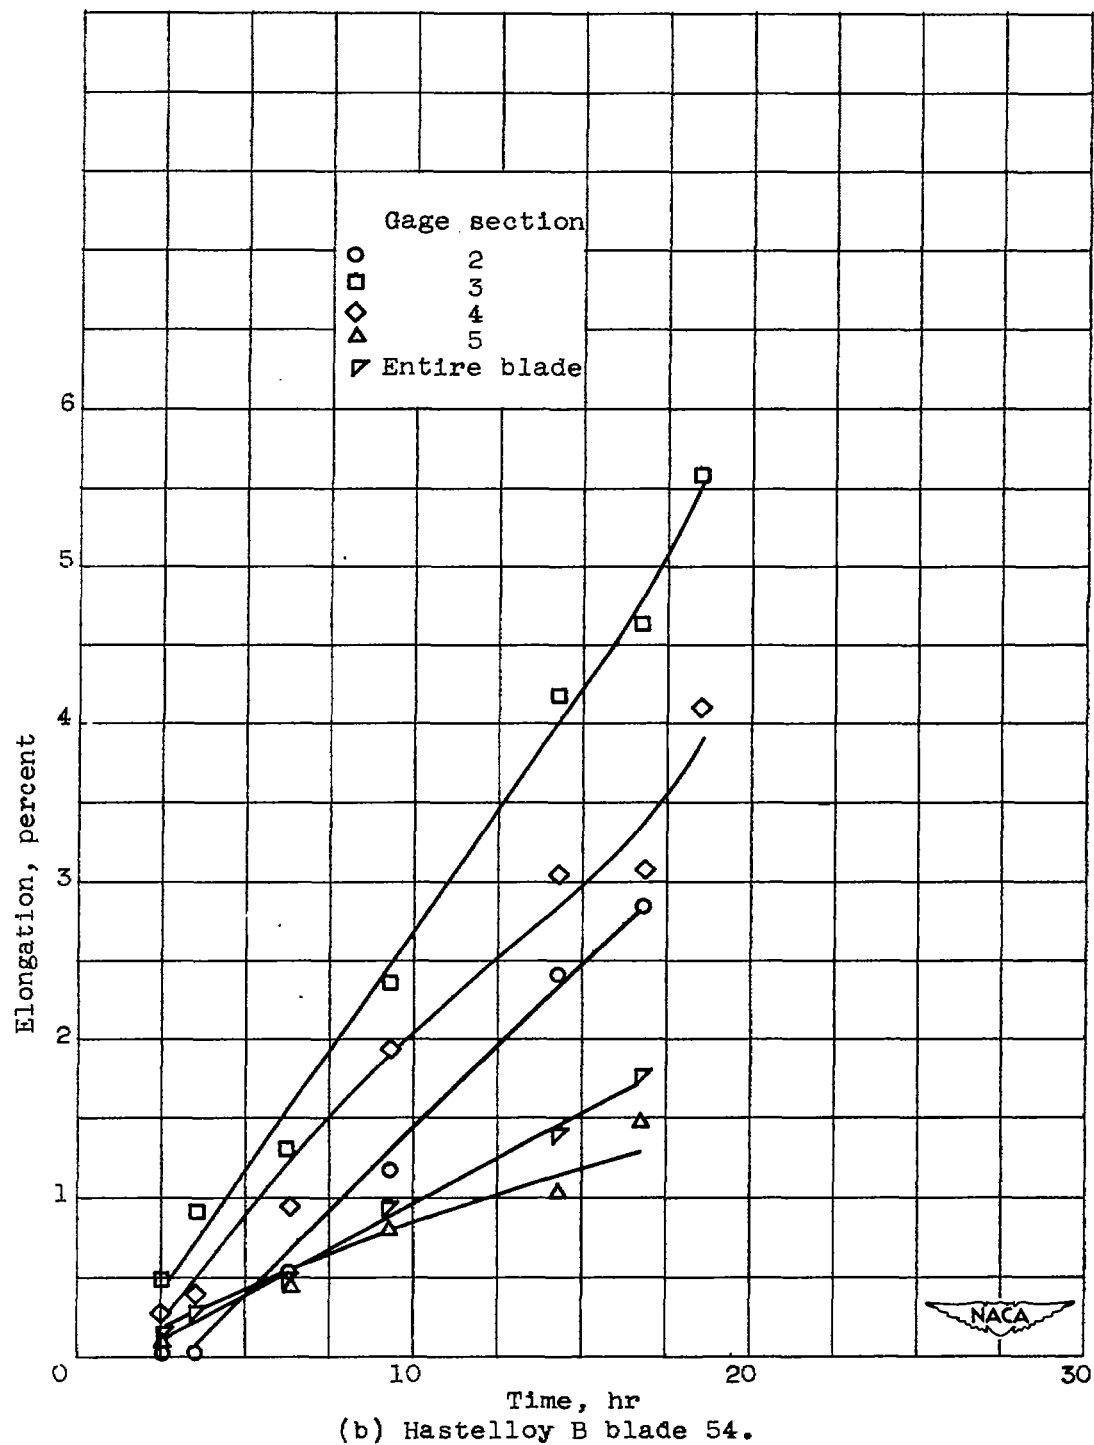
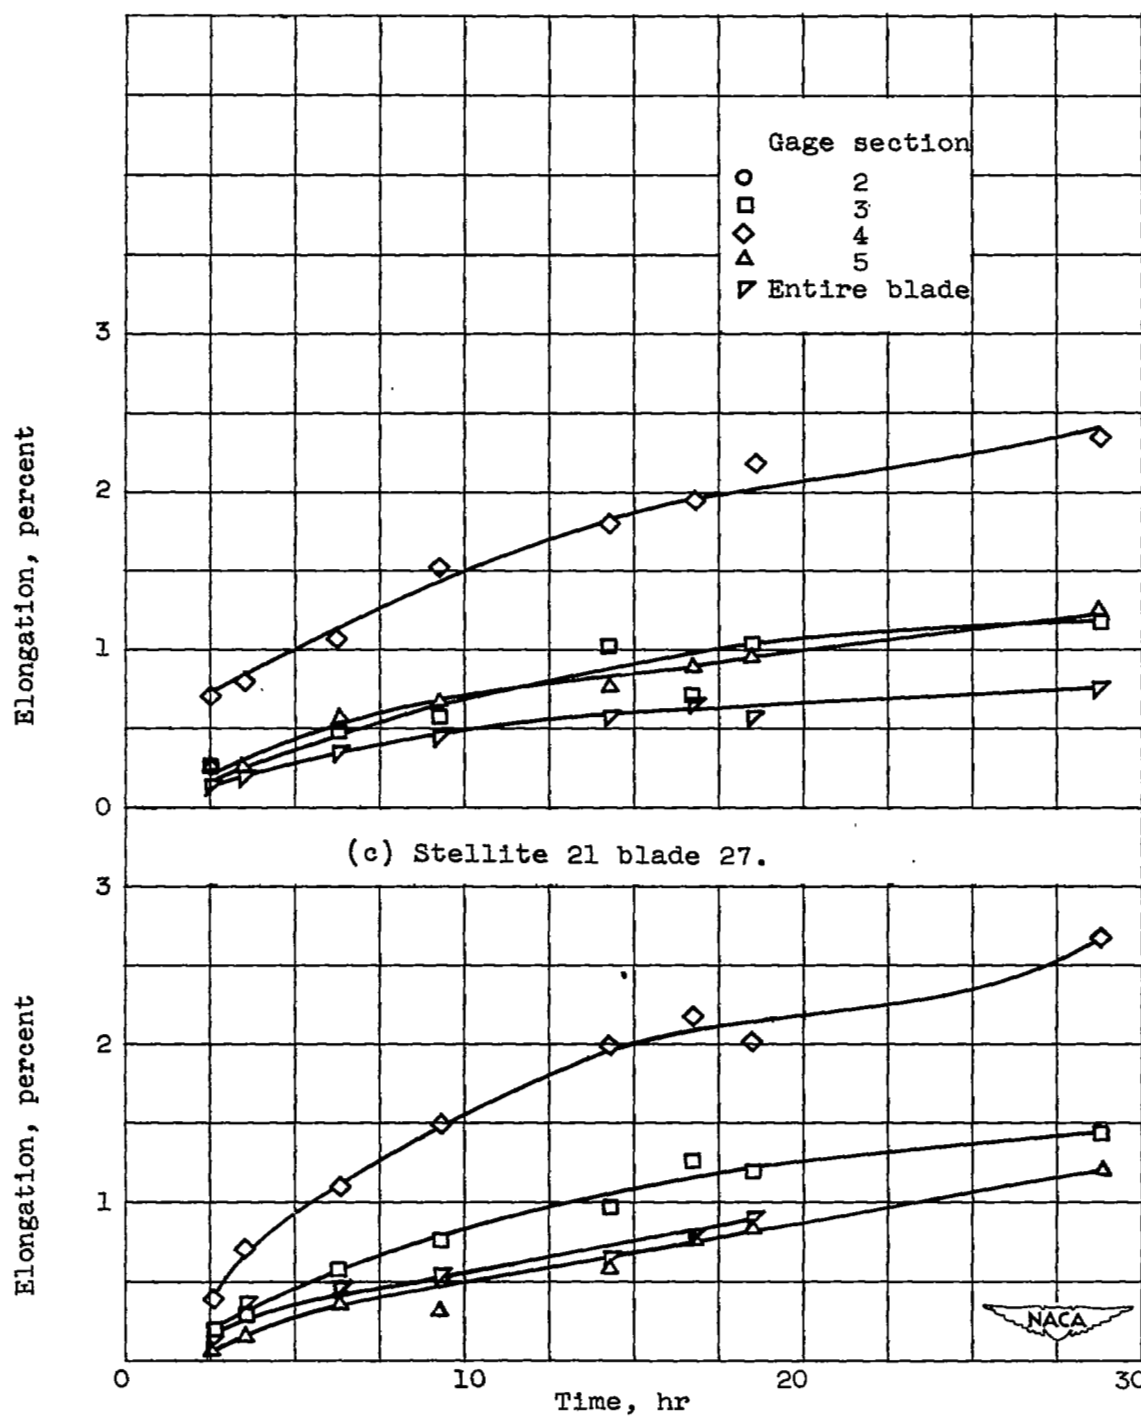
(a) Hastelloy B blade 40.

Figure 16. - Blade elongation during turbine operation for those sections having greater than 1 percent elongation.

Figure 16. - Continued. Blade elongation during turbine operation for those sections having greater than 1 percent elongation.

Figure 16. - Concluded. Blade elongation during turbine operation for those sections having greater than 1 percent elongation.

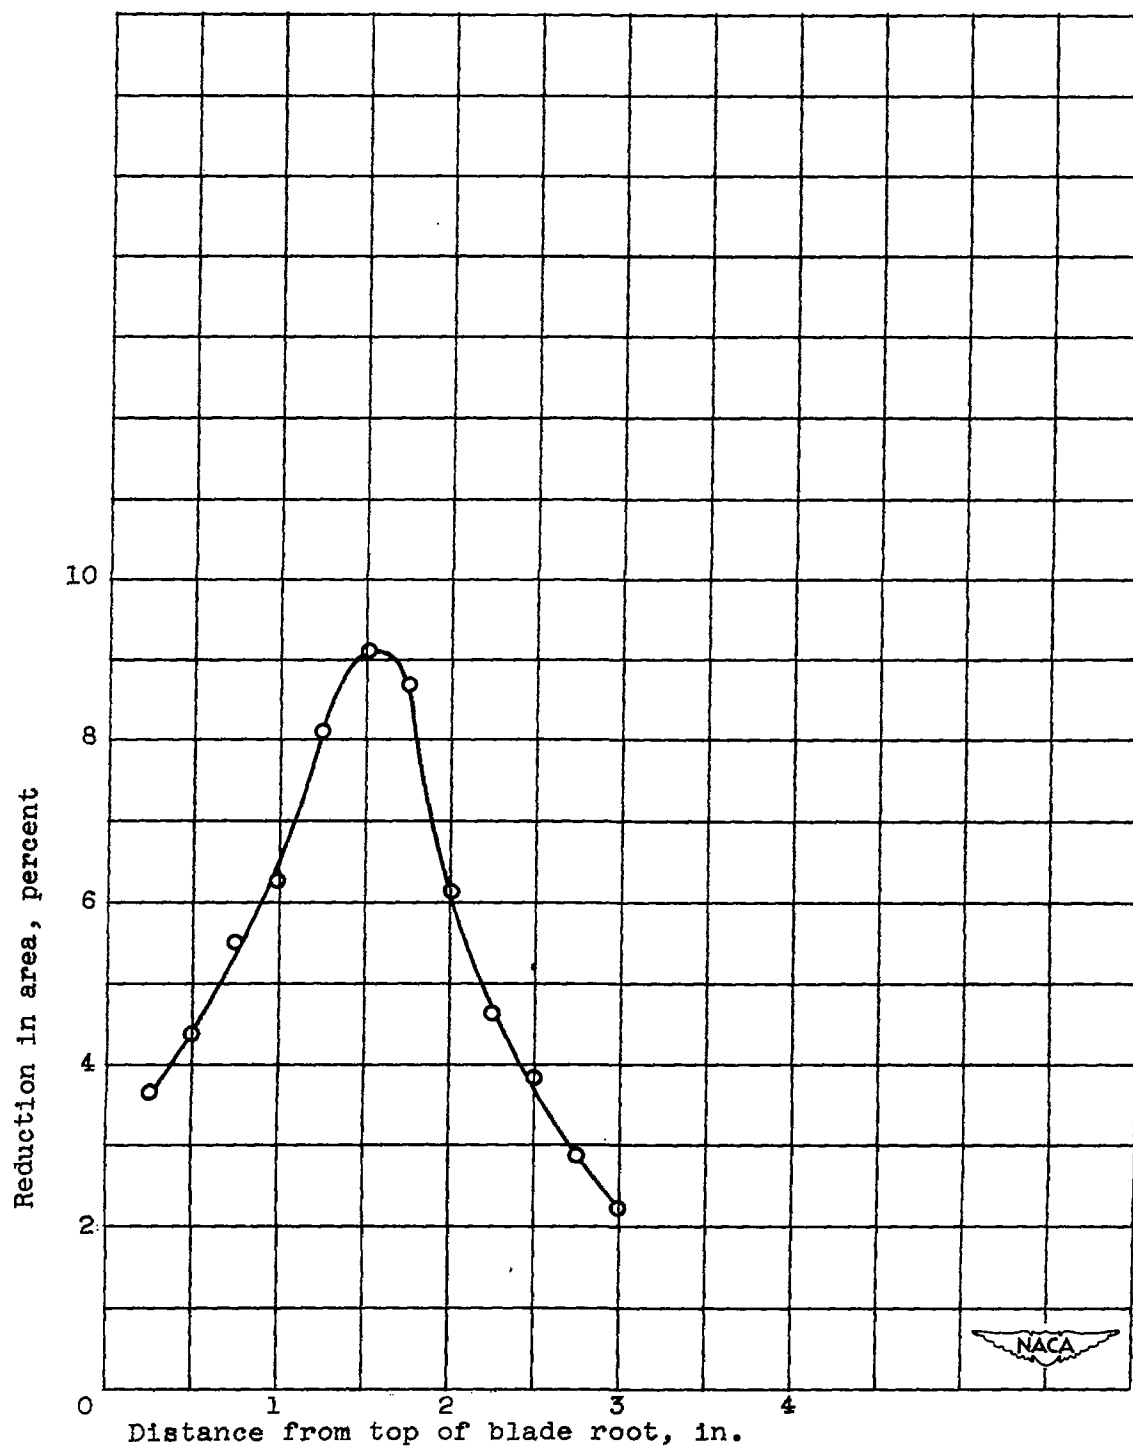
The results of the reduction in area measurements of a Hastelloy B blade after 28.75 hours (115 cycles) of operation are shown in figure 17. These results are only qualitative inasmuch as they represent the change in area of a single blade compared with the average area of the Hastelloy B blades prior to operation. The measurements of the area of a Stellite 21 blade after operation did not indicate any measureable reduction in area.

Figure 17. - Reduction in area in Hastelloy B blade after 28.75 hours (115 cycles) of operation.

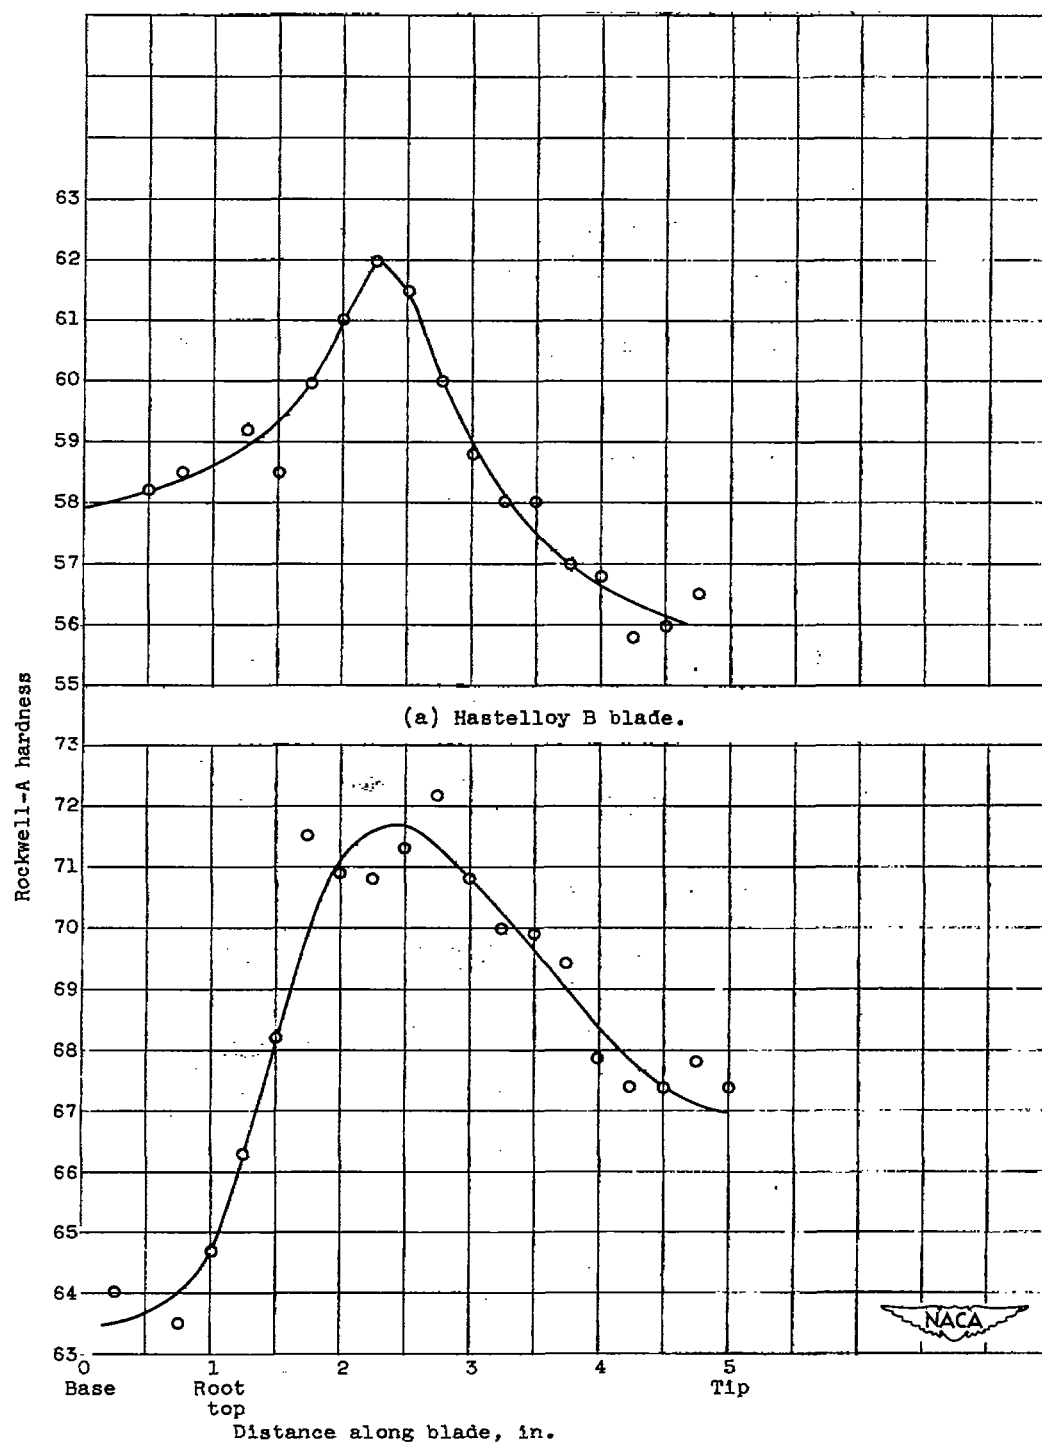
Typical hardness-distribution curves are shown in figures 19 and 20 for the Hastelloy B and Stellite 21 turbine blades, respectively, after 28.75 hours (115 cycles) of operation. Each point on these plots represents an average of three to five Rockwell-A hardness values. The hardness distributions in the blades that failed were generally the same as those in figure 19. These plots indicate that the maximum hardness occurs around the center of the airfoil section of the blades.

Figure 19. - Hardness distribution for blade after 28.75 hours (115 cycles) of operation.

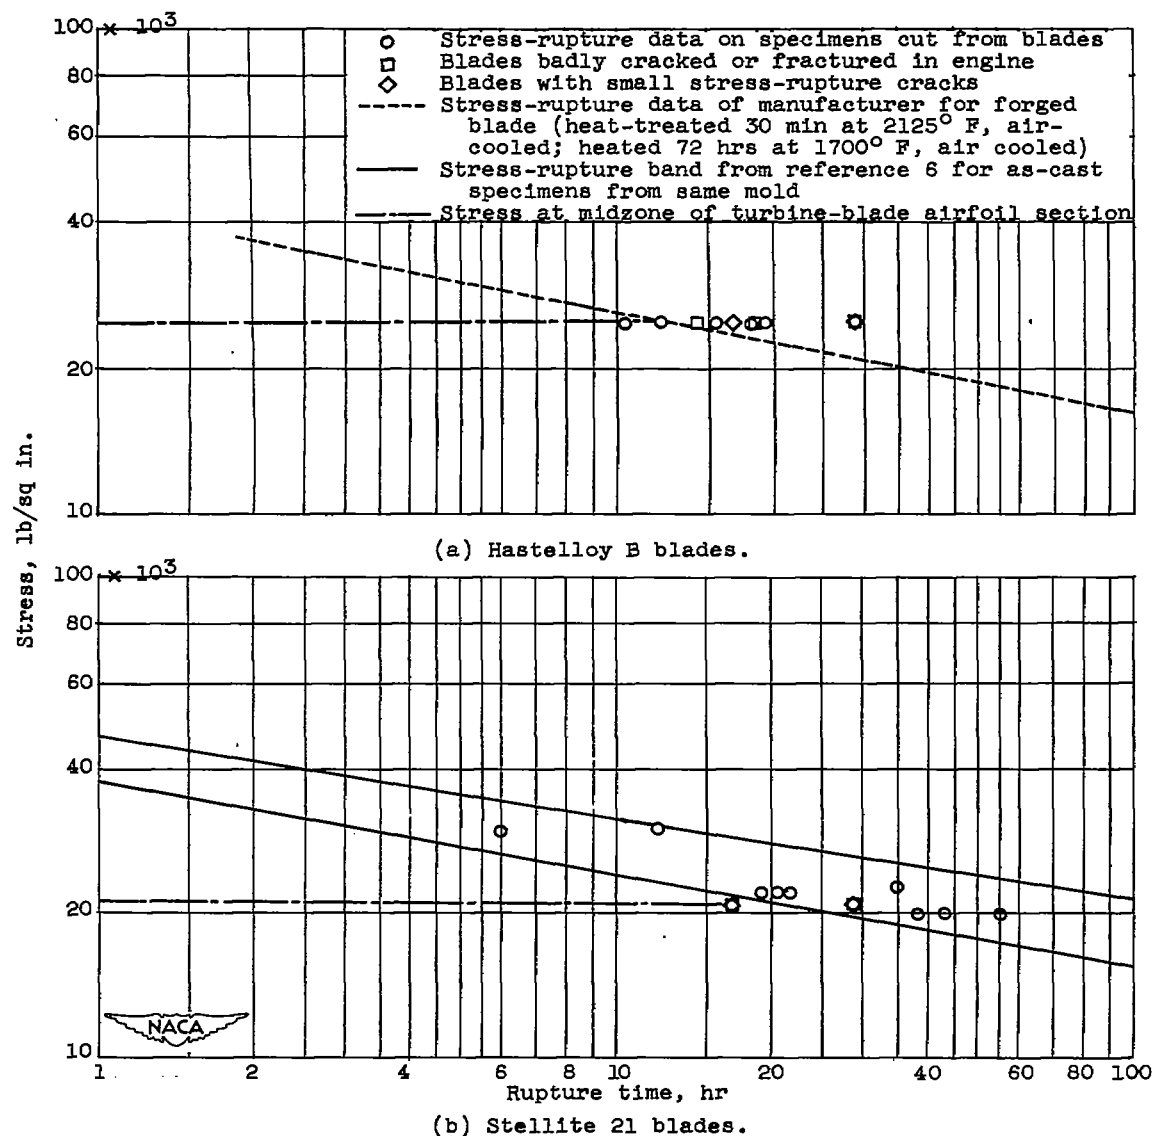
The results of the stress-rupture and engine tests of the Hastelloy B and Stellite 21 blades are compared with available strength data for these alloys in figure 20. All the blade failures are plotted on this curve, although some of the failures apparently were not of the stress-rupture type, to determine if stress rupture might have contributed to initiating failure even though metallurgical examination revealed no evidence of stress-rupture cracks. The design stress-rupture data of the manufacturer for Hastelloy B at 1500° F, although a heat treatment different from that of this investigation was used, compare favorably with the results of the rupture tests on specimens cut from blades. At a stress of 25,000 pounds per square inch, the manufacturer's data indicate a rupture life of 12 hours; the blade specimens had rupture lives ranging from 10.3 to 19.2 hours, or within the range that might be expected from the manufacturer's data. In the case of the alloy Stellite 21, the results of the blade-specimen rupture tests fall within the stress-rupture band for the alloy. For a maximum blade temperature of 1500° F, the minimum rupture life of the Hastelloy B blades at the average stress of 25,000 pounds per square inch would be 10.3 hours, the minimum rupture life of Stellite 21 blades at the average stress of 21,000 pounds per square inch would be 21 hours (minimum predicted by stress-rupture band).

rupture tests (fig. 20). This failure, however, could not be classed as a stress-rupture failure because unlike a rupture failure, it was transcrystalline in its propagation and had a smooth fracture surface. The failure started at a point on the blade above the zone of critical stress and maximum temperature (fig. 7). From the nature of the fracture, therefore, vibratory stresses were probably a principal cause of this first failure. After 16.75 hours of operation, the majority of the remaining Hastelloy B blades developed intercrystalline leading-edge cracks characteristic of the stress-rupture failures of the blade specimens. Inasmuch as this operating time was within the stress-rupture failure times expected from operating conditions, these cracks can be considered as evidence of the beginning of blade failure by stress rupture. The distribution of these cracks along the leading edge (fig. 11(a)) suggests that corrosion or localized hot zone along the leading edge may have been partly responsible for their formation. However, the correlation of the nature of the crack propagation and the time of the crack formation with the results of the stress-rupture tests on blade specimens indicates that other contributing causes such as corrosion are of less importance. As the engine operation continued, the remaining Hastelloy B blade fractures progressed from these leading-edge cracks. The failures progressed by two mechanisms, fatigue and stress rupture. Hastelloy B blades 4 and 34 (figs. 11(b) and 11(d)) fractured after 18.47 hours of (1.72 additional hr) operation as a result of a condition favorable for fatigue fracture having been set up by the leading-edge cracks. The vibratory stresses in the blades were therefore merely propagating a failure originated by stress rupture. In Hastelloy B blade 54 after 28.75 hours (12 additional hr) of operation, fracture occurred by the progression of the initial crack across the blade continued by a stress rupture following an intercrystalline path. Some of the original Hastelloy B blades were still in operation at times in excess of the predicted rupture life, which would be expected since a complete stress-rupture band for the alloy was unavailable, making the maximum blade life unknown. All but three of the original 27 Hastelloy B blades, however, had cracked or fractured at the conclusion of operation, indicating that failure had started in all but three blades.

cracking was detected in two Stellite 21 blades. The nature of this cracking is characteristic of the beginning of failure by stress rupture. Because the first cracked Stellite 21 blades were removed from the engine, their exact life cannot be determined. However, because seven of ten cracked Hastelloy B blades left in the engine at the same time operated for 12 additional hours without failure, the cracked Stellite 21 blades would probably have operated for the length of time predicted by the rupture band before failing. At the conclusion of operation, Stellite 21 blades 1 and 3 were fractured. Inasmuch as blades 1 and 3 were close to the fractured blade 54 (fig. 14), failure was probably caused by impact with the upper half of the fractured blade. This mechanism of failure is corroborated by the following facts: (1) The fracture surfaces were not of the stress-rupture or fatigue type, and (2) the fracture surfaces were covered completely with a light straw color indicating that the entire fracture occurred at the same time and that the surfaces were exposed for only a very short time. Because these failures are the result of extraordinary causes, they will not be considered in evaluating the performance of alloy Stellite 21. The only additional evidence of failure in Stellite 21 at the conclusion of operation were the two additional blades that had formed intergranular cracks of the stress-rupture type after 28.75 hours of operation.

Figure 20. - Comparison of stress-rupture properties and engine blade life at temperature of 1500° F for alloys Hastelloy B and Stellite 21.
